Manhole Inspection Summary

Manhole # S19I__110MH

Insp Date: **9/22/09 12:55 PM**

Location Address: **23 SOUTH CALVERTON**

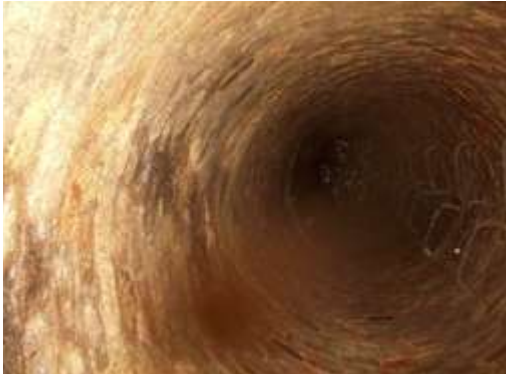
Too Deep and Too Much Steam to Take the Pictures

Steam in MH

Steam

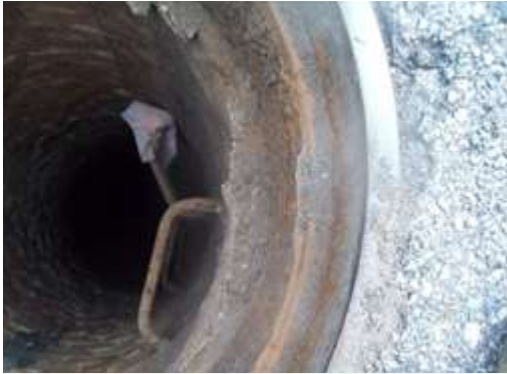
Defect 1

Condition: ☐ Sound ☒ **Cracked** ☐ Leaks

FRAME Cracks
